# Manhole Inspection Summary

Manhole # S33GG\_009MH

**Inspection** ☐ Is Incomplete Rating: **5) Immediate Attention Required**

**Location** Address: **21 MARYLAND AVE**

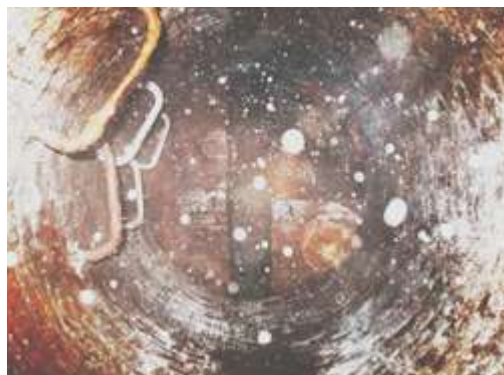
Top View

Corroded steps. Evidence of surcharge - Bench debris.

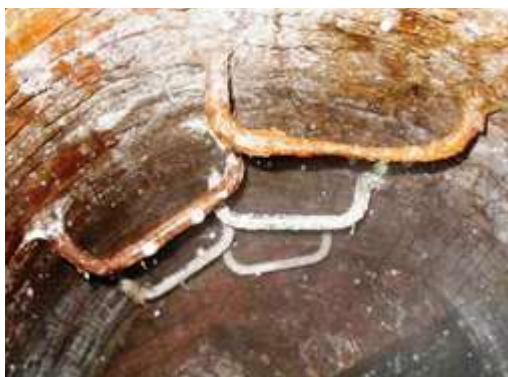
Defect

Corroded steps. Corbel and Barrel infiltration.

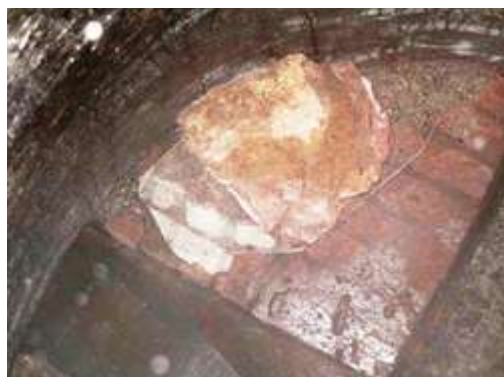
Defect

Missing material from the Barrel wall.

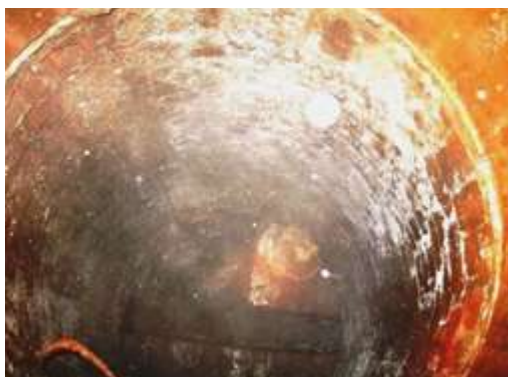
Defect

Frame leaks. Adjustment deterioration and infiltration. Corbel and Barrel infiltration.

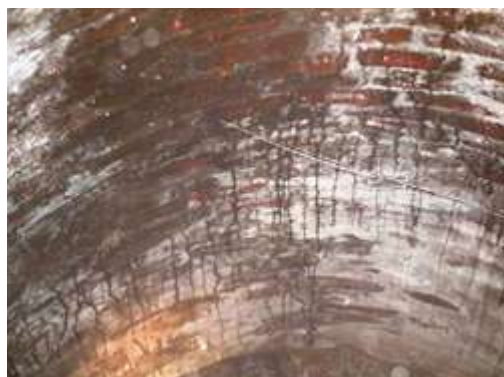
Defect

Corbel infiltration.

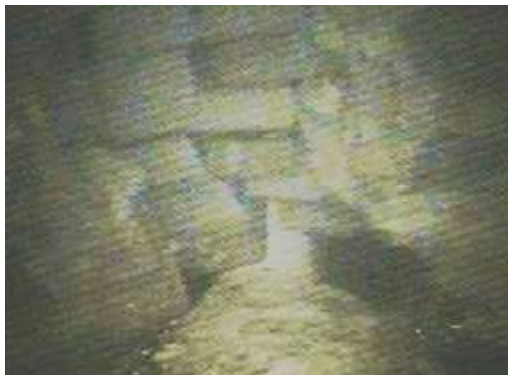
### Defect

Barrel deterioration, loose brick and infiltration. Void - may not be structurally sound.

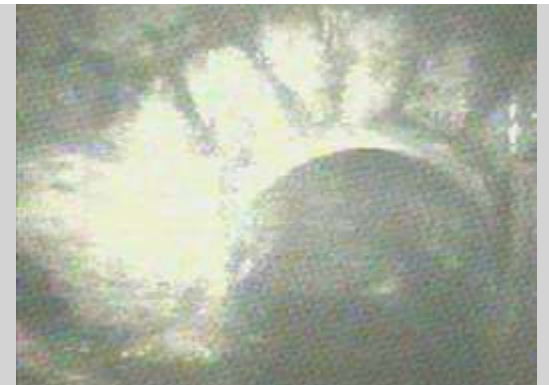
### 8 in. Circular Gravity Sewer Pipe In @ 3 O'Clock

Infiltration: **Evidence** Pipe Seal Cond: **Unknown**

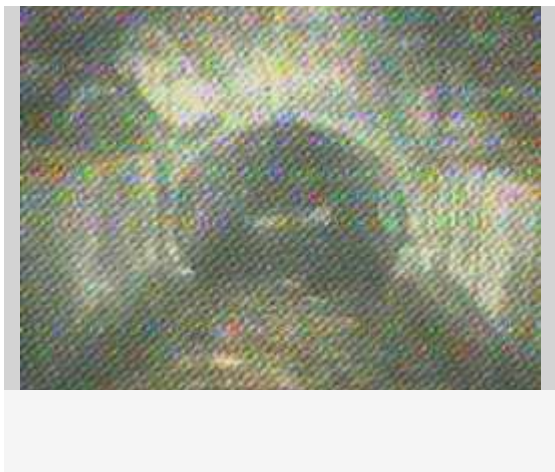
8 in. Circular Gravity Sewer  
Pipe In @ 6 O'Clock

Deposits: ☐ None ☒ **Mud** ☒ **Sludge** ☒ **Debris** ☐ Grease

Silt Depth: **1** (in.) Deposits Extent: **Light**

Infiltration: **Evidence** Pipe Seal Cond: **Unknown**
